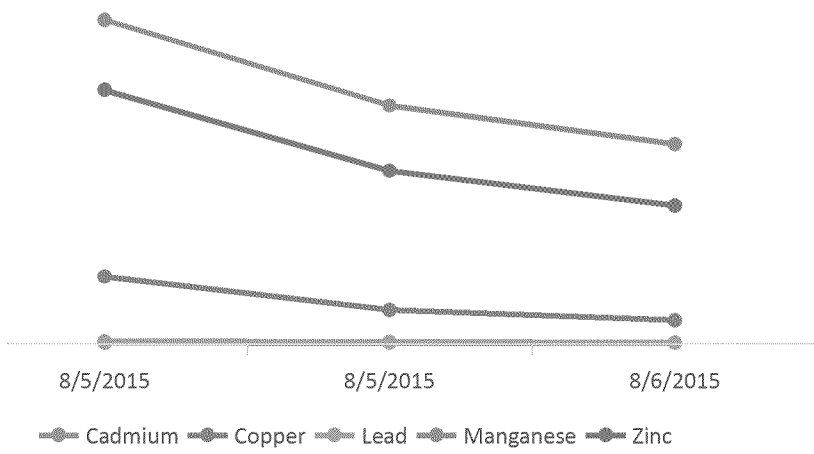
Location: CC48

ocation ID	Sampled	Cadmium	Copper	Lead	Manganese	Zinc
CC48	8/5/2015	30.6	2260	73.9	10900	8540
CC48	8/5/2015	19.1	1130	54.1	8020	5820
CC48	8/6/2015	14.2	786	30	6720	4650

12000
10000
8000
6000
4000
2000
0
